**DEVELOPMENT OF
HIGH STRENGTH COLUMBIUM
AND TANTALUM ALLOY TUBING**

THIRD QUARTERLY PROGRESS REPORT

JUNE 1, 1963 TO AUGUST 31, 1963

**Astronuclear Laboratory
Westinghouse Electric Corporation**

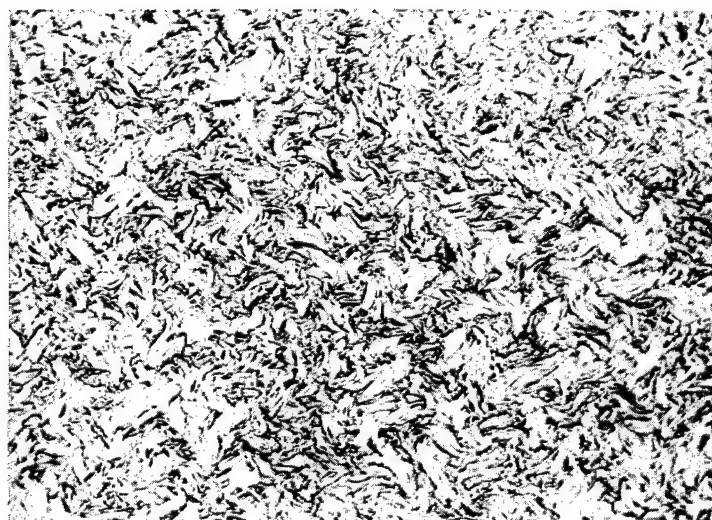
Figure 2 - "As-Extruded" Microstructure of T-111-2, Transverse
Section, 150X

Increasing the temperature and speed did not affect the as-extruded ^{Cb, Ta} microstructure of the T-111 extrusions. The 2300°F extrusion temperature is below the recrystallization temperature of T-111. The "as-extruded" microstructures observed for both Phase I T-111 extrusions were similar and were typical of as-worked material. A representative microstructure taken from the nose section of extrusion T-111-1 is shown in Figure 2. As noted earlier the as-extruded T-111 had an excellent surface condition with no significant surface contamination.

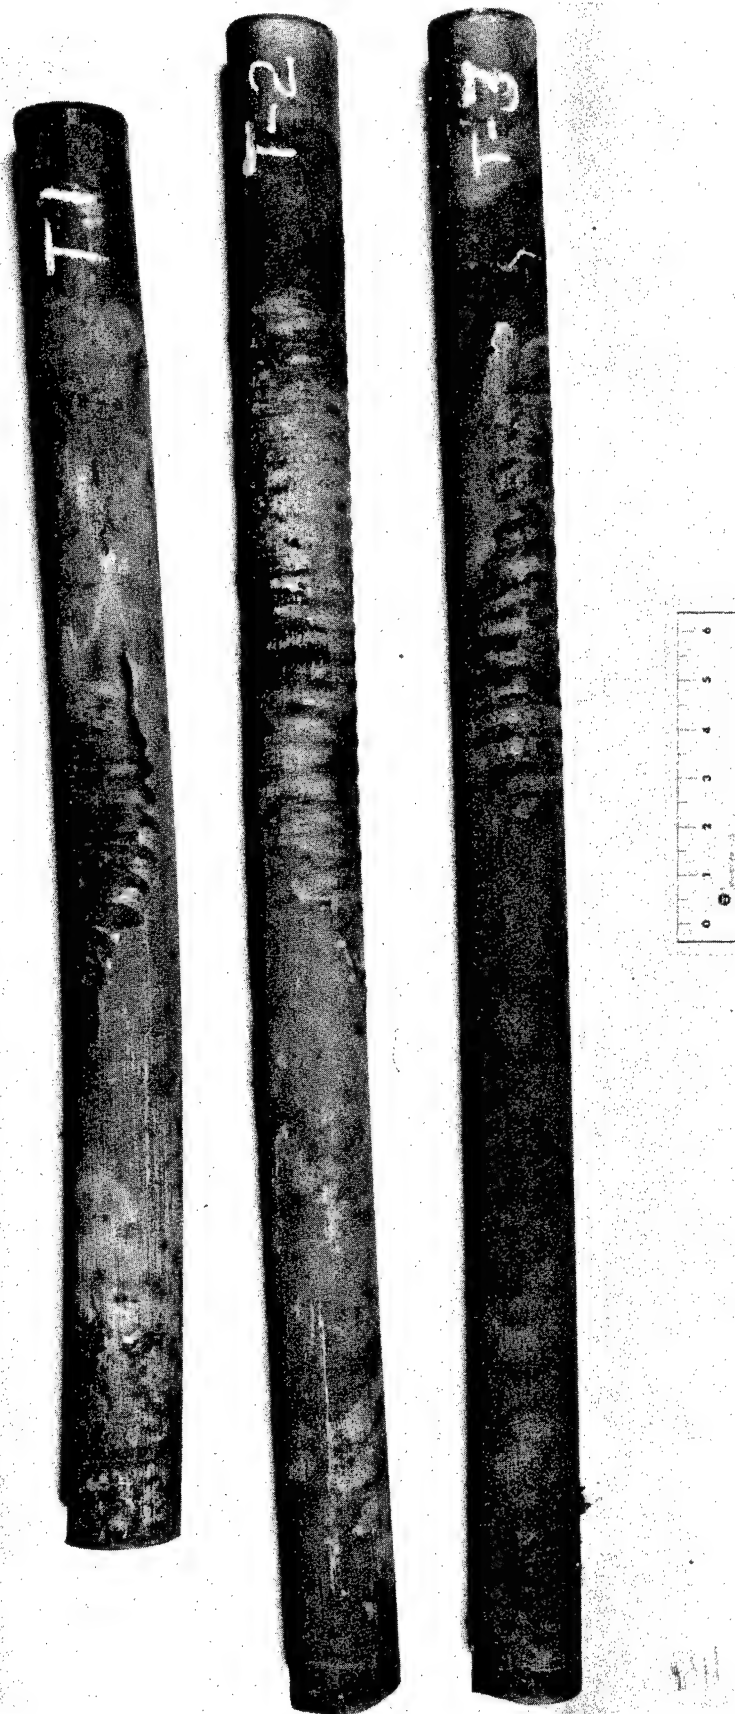
Figure 9 - Phase II T-111 Tube Blank Extrusions

Extrusion of the Phase II B-66 and T-111 billets to a nominal 2 inch O.D. x 0.25 inch wall tube blank was accomplished at the facilities of Nuclear Metals Inc. on July 23 and 24, 1963. The results of the tube blank extrusion are summarized in Table IV. The mild steel clad extrusion billets were heated in an argon purged retort for a minimum of four hours prior to extrusion. For the B-66-II-1 extrusion, the mandrel was heated to 900°F. However, during the extrusion the mandrel hung up in the billet and was pulled through the die. The mandrel was not heated for the balance of the extrusions. T-111-4 stalled the press for no apparent reason. This billet was ~~reprocessed~~ remachined at Nuclear Metals Inc. and then returned to WANL for annealing. The billet was annealed for one hour at 1600°C (2900°F). The annealed hardness was 225 DPH. Eight pounds were lost from T-111-4 during the re-machining operation, thus reducing the total starting weight of the Phase II T-111 extrusion billets to 142 pounds. T-111-4 was re-extruded successfully on September 9, 1963. The mild steel cladding was removed from the extrusions by pickling. The B-66 and T-111 tube blank extrusions are shown in Figures 9 and 10. Moderate to severe rippling was observed on all the extrusions with the exception of T-111-4 which was free of ripples. B-66-II-2 exhibited generally severe rippling and cir-

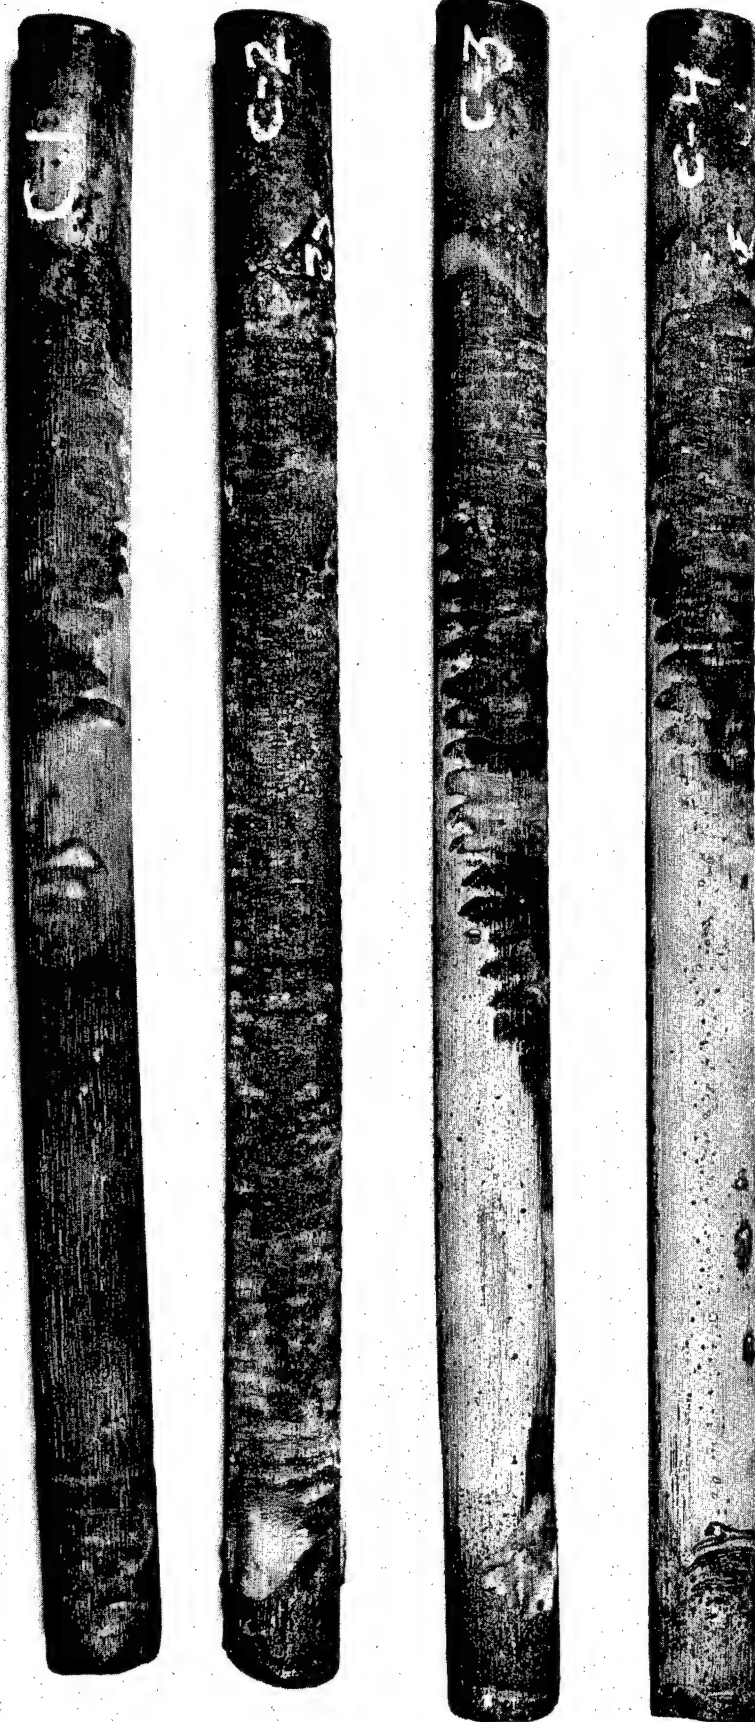
Figure 10 - Phase II B-66 Tube Blank Extrusions
